Gold Hill Cement Power Plant (Former) Targeted Brownfields Assessment

Gold Hill, Oregon

Technical Direction Document: 15-01-0009

July 2016

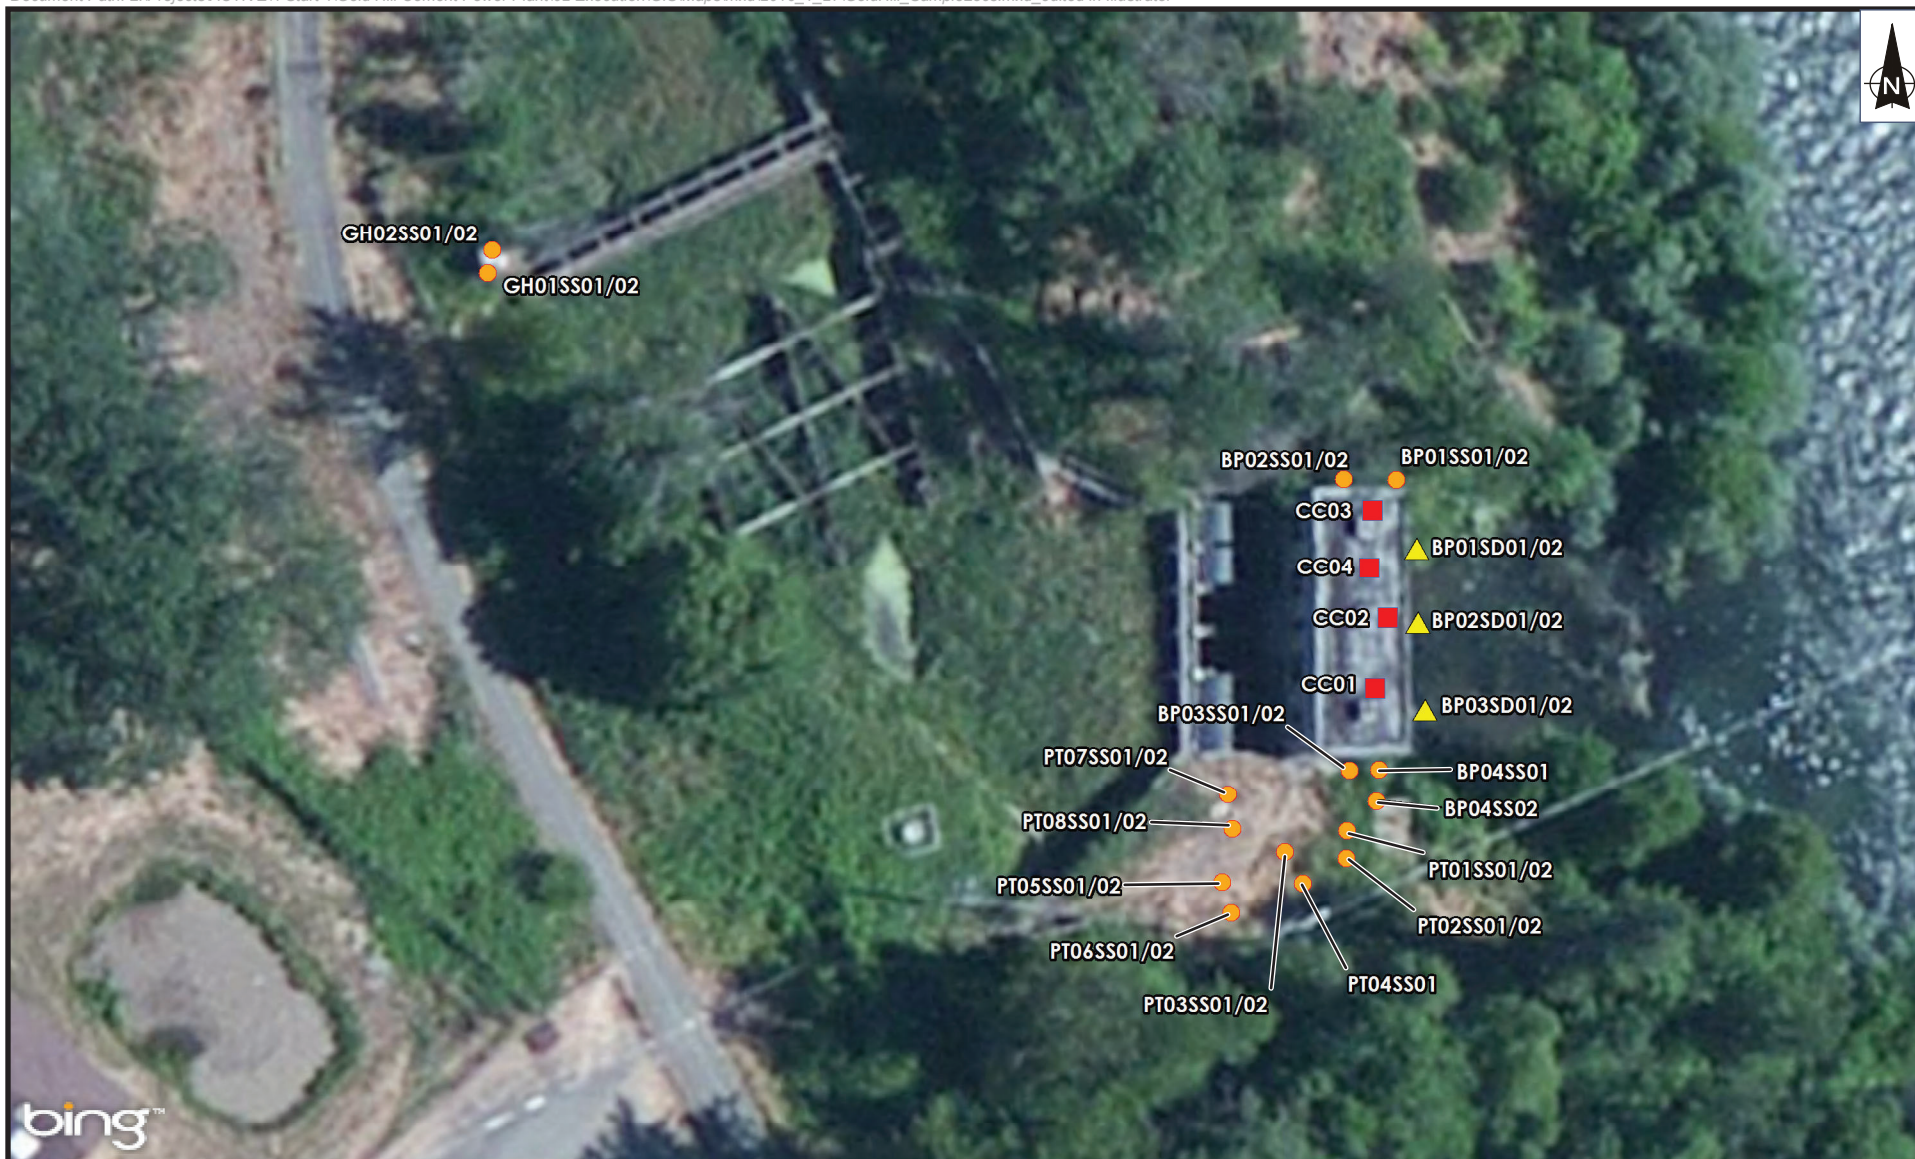
A small cove on the Rogue River abuts the power plant to the east. Six sediment samples were collected from three separate sample locations within this cove along the east side of the power plant (Figure 4-1). At each location, samples of sediment resting on the foundation of the power plant were collected from 0 to 6 inches bgs and 6 to 12 inches bgs.

To determine if potential leaks or spills from power transmission equipment have contaminated surface soils, surface soil samples were collected from eight separate locations (PT01SS through PT08SS) near the suspected location of the former power transmission equipment (Figure 4-1). Sampled locations were chosen based on aerial photograph interpretation and the positions of former foundations located during the field event.

To determine if leaks or spills have contaminated the concrete floor of the power plant, six concrete samples were collected from the floor of the power plant structure. Samples were to be collected from areas of visible staining with a 3-inch core drill to a depth of 3 inches. However, due to limited surface staining, as well as the small area of the former power plant structure, only four concrete samples were collected (Figure 4-1; see the SPAF in Appendix E). Further, due to the absence of staining at depth, sample cores were only drilled to a depth of 2 rather than 3 inches. Sample locations were located in areas where heaviest staining was noted. Sample CC01CF was collected on the north side of the south turbine, sample CC02CF was collected from the switch room, sample CC03CF was collected on the north side of the north turbine, and sample CC04CF was collected between the north and middle turbines. All samples were submitted for total TPH-Dx, PCB, and SVOC analysis: one sample (CC02CF) was also submitted for dioxins/furans analysis.

- Concrete Sample Locations
- ▲ Sediment Sample Locations
- Surface Soil Sample Locations

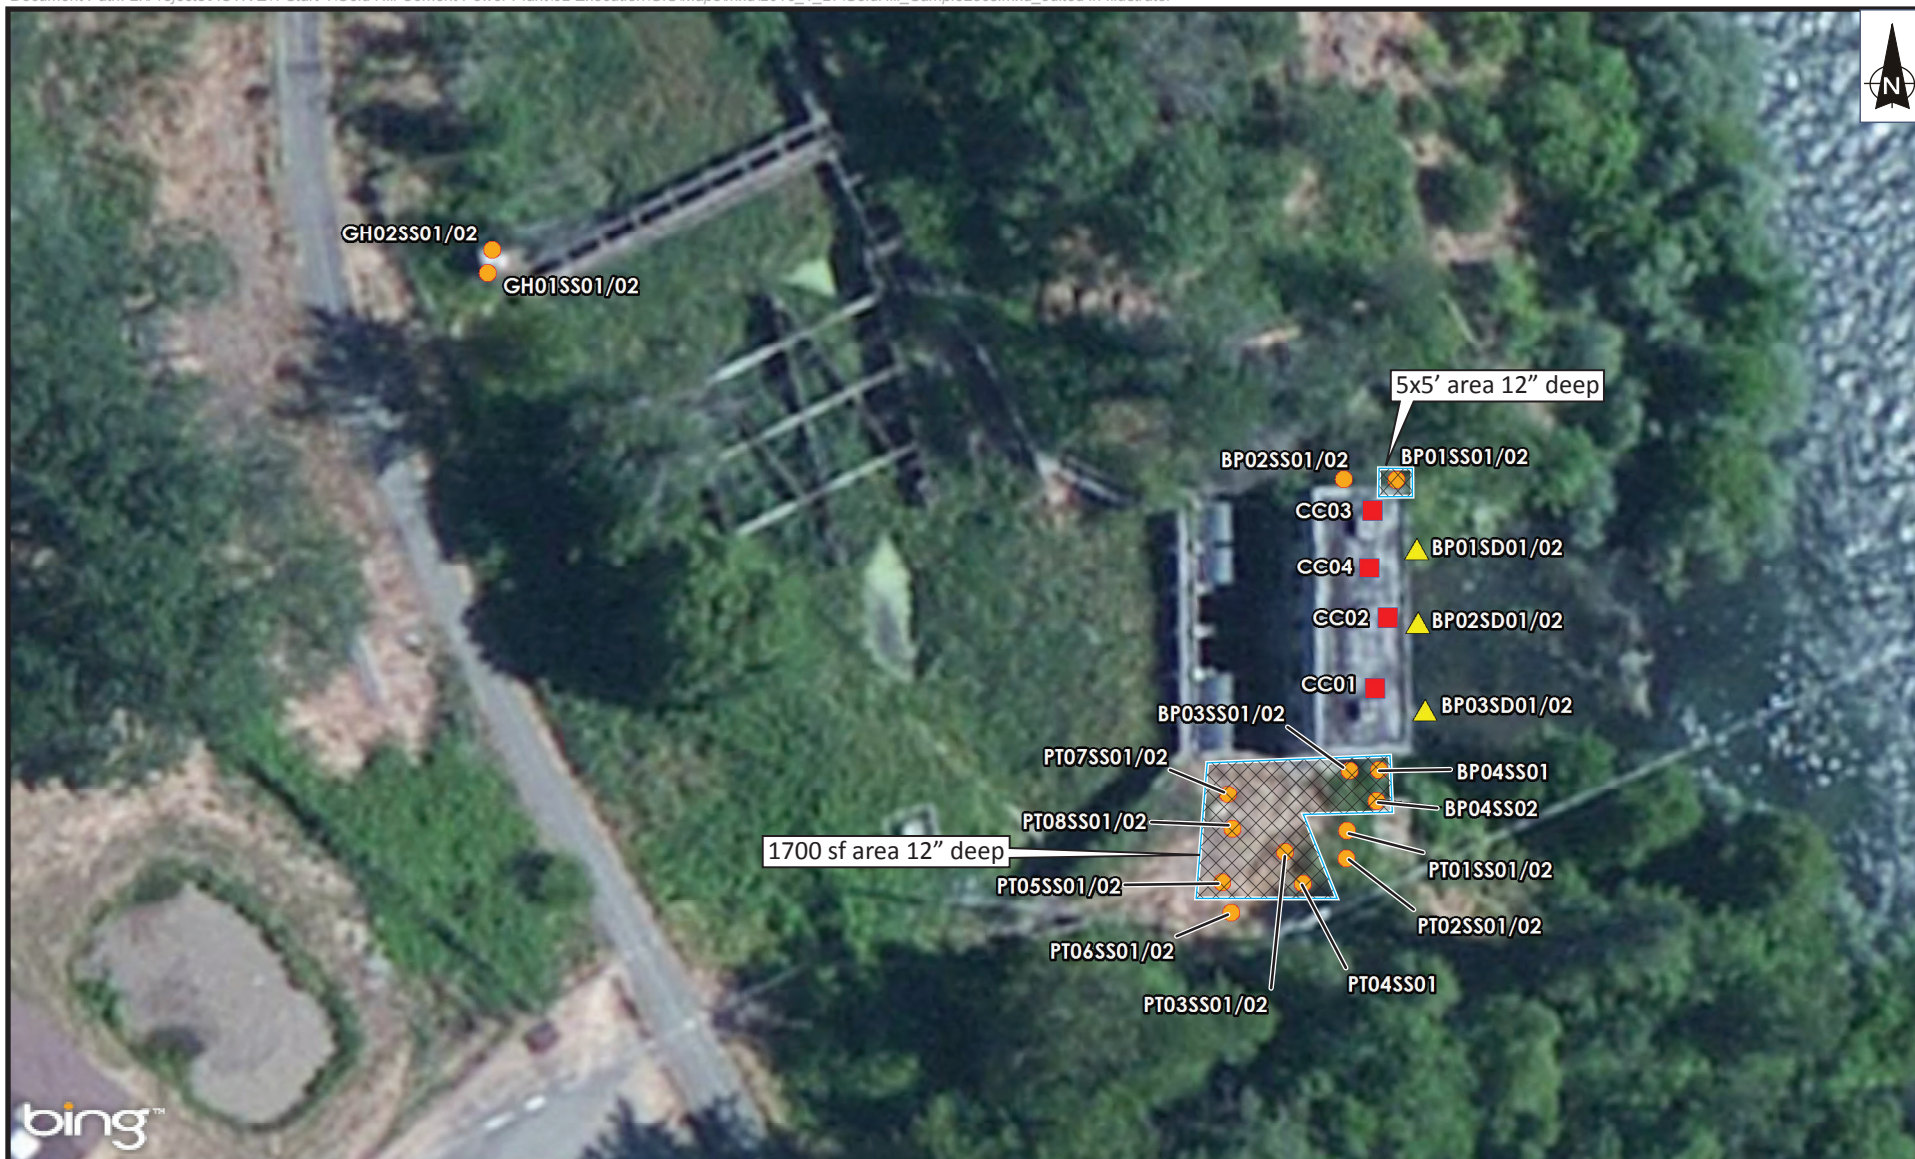
- Concrete Sample Locations
- ▲ Sediment Sample Locations
- Surface Soil Sample Locations
- Excavation Area

The cleanup option that is considered to be both cost-effective and protective involves excavating the soil that exceeds removal action levels and disposing of it at an off-site, licensed disposal facility. For this option, it is assumed that the power plant structure and foundation will remain in place.
